Latest News

Fyfe Wilson Ltd

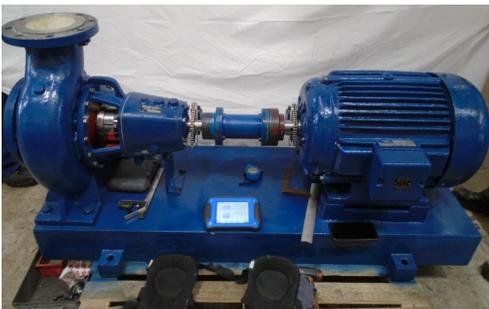
Fyfe Wilson were asked to change a mechanical seal on a pump that kept leaking. We investigated why the pump was leaking and identified from the wear on the seal that there was an alignment issue. Once we connected up our shaft alignment tool, we proved that the alignment was significantly

out between the motor and the pump. This would cause excess pressure on one side of the seal and cause it to wear very quickly, leading to it leaking. Normally we would shim the pump or motor to adjust the alignment but in this case, the adjustment was too big to just shim so we opted to machine the baseplate.

The pump following repair being aligned

The motor and pump were removed from the baseplate and it was taken into our machine shop where the engineer milled it true. It was then repainted before fitting the pump and motor back on and aligning again, this time using shims. The process worked and the pump has not leaked since being put back in operation. The cost of all this work was less than the cost of 2 mechanical seals which normally were replaced every 3 months. It has been running now for six months on the same seal that was fitted by Fyfe Wilson engineers.

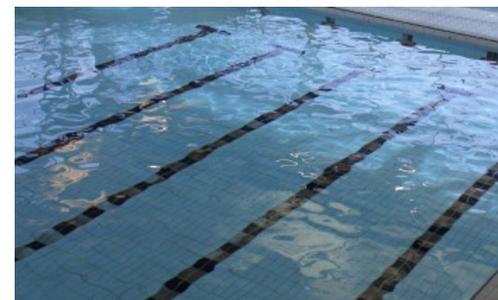
Recently we had a phone call from a swimming pool whose extract fan had failed. We gathered the details and established that it was a 22KW 4 pole motor that had failed. We went down to site with the motor to establish that not only had the extract fan failed, but the intake fan had failed as well. We had a second 22KW motor in stock so our delivery driver took that down to the site for our engineers to fit. We established that there was a wiring fault on the installation and this was corrected by our

electrician who was attending site with our mechanical team. We were working until ten o'clock at night to get it up and running so that the pool could open the next day. The bill for this was less than the penalty for having the pool closed for one day.

We went back the next day to sort out the backup. The backup had failed several months earlier but had not been rectified. To save money, we took all four motors back to our works to see if any could be repaired cheaper than purchasing a new one. Three were burnt out so were uneconomical to repair but one tested ok after it was washed and stoved. New bearings were fitted and the motor was painted. It was then taken back along with a new motor that was ordered for next day delivery.

Several modifications were made to the controls as the wrong motors were connected in the panel and all was well.

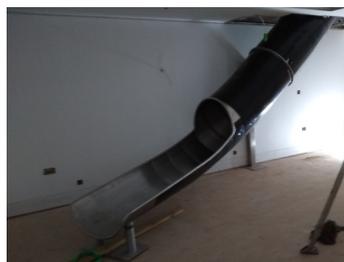
We recently had a bit of a strange enquiry. Could we fit a slide into a residential property. The ceiling was too low to get our porta gantry in so we had to look at other options. Using an A frame, block and tackle, some long slings and some manpower we devised a way to safely lower the slide through the upstairs floor and into the room below and fixed it into place. As the

The bottom of the slide

builders were prevented from continuing their works until the slide was installed, the property owner wanted this done as quickly and efficiently as possible. We managed to get the equipment and a team together to do it the next day. Unfortunately, the slide would not fit properly on the floor, but a quick phone call to our works and a plinth was made and delivered to site so that we could finish the job on the same day.
