Latest News

Farewell Station Works

Fyfe Wilson & co Ltd

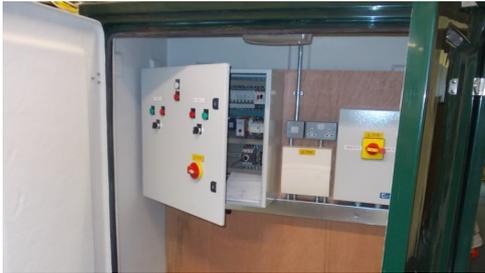
New Control panel and enclosure

We have recently completed the first three control panels to be installed on pumping stations. Two have been installed and the final one is awaiting civil works to be com-

pleted. The control panel features digital telemetry signal output and flip flop relay to keep the pumps running when necessary. A generator change over switch and input plug allows the pumping station to be connected quickly to a generator in the event of a mains failure. The installation also includes a high level beacon and audible alarm as well as a light and twin sockets contained within the GRP enclosure.
